QUINNIPIAC RIVER FUND FINAL REPORT- 2019

Group/Organization Name: City of Meriden, Dept. of Public Works

Project Name: Eliminator Hooded Outlets Pilot Program

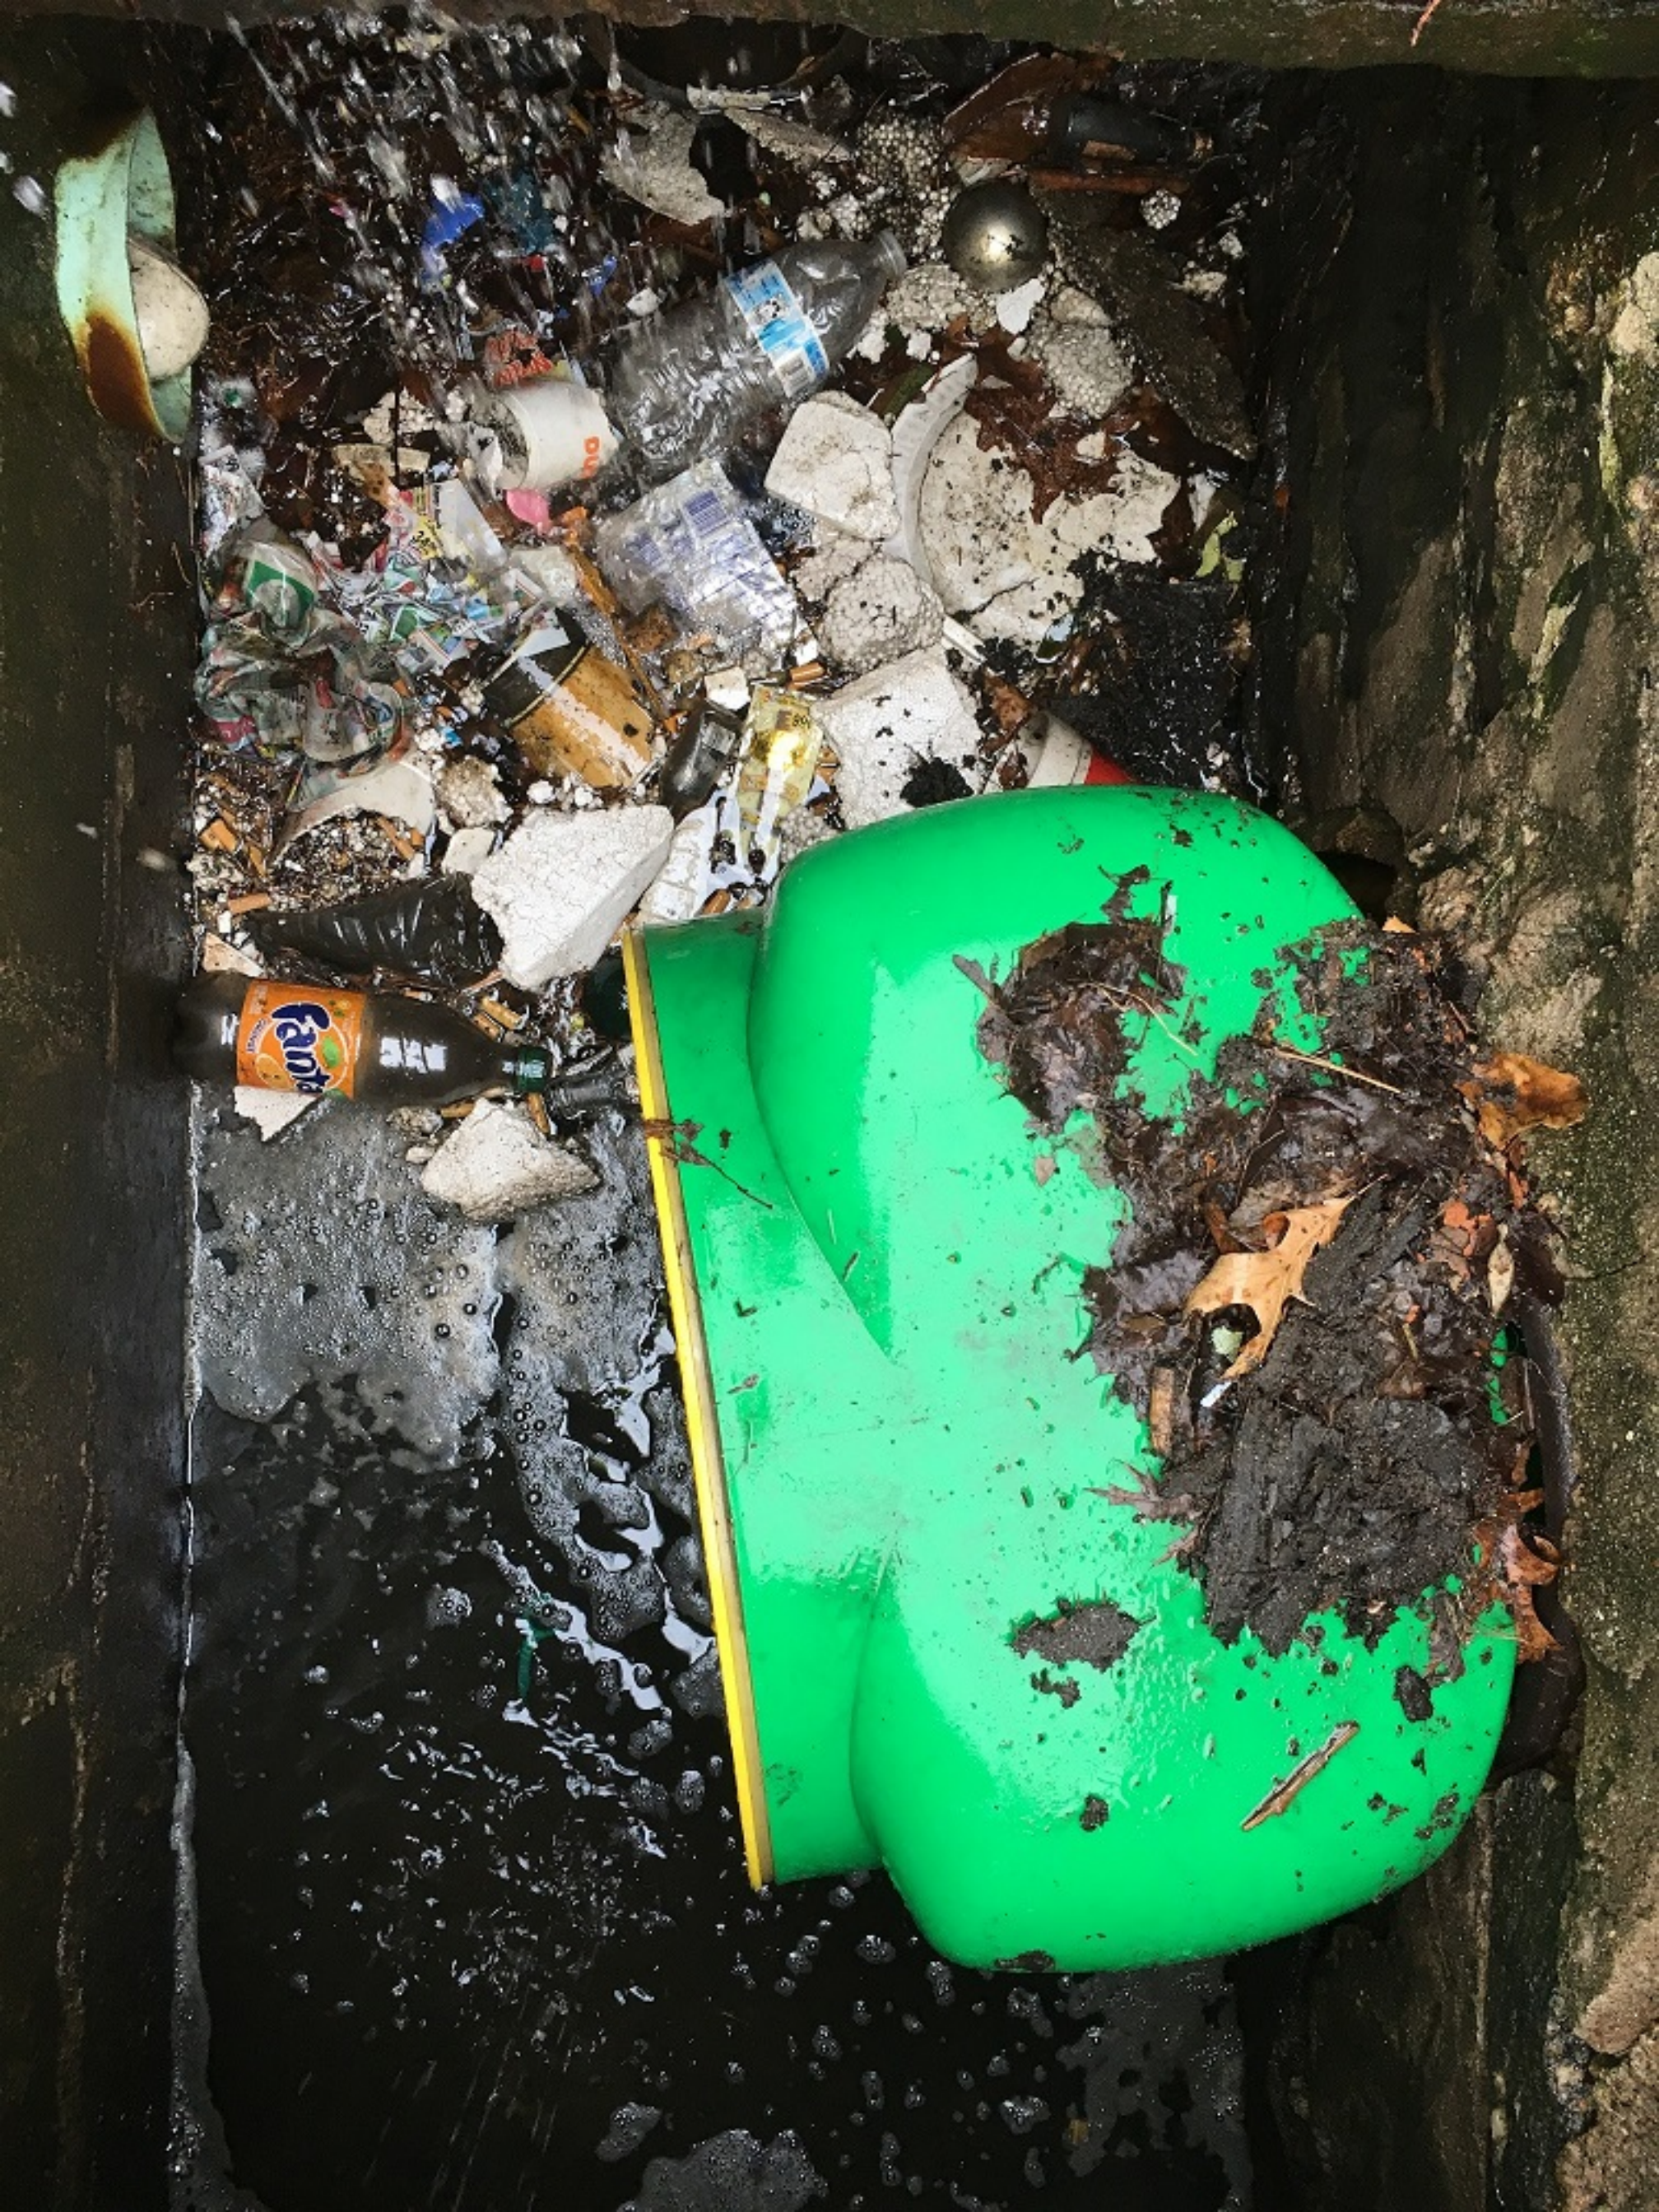
Effectiveness of Removing Debris – Since the installation of the Eliminator hooded outlets on August 26 2019 we have seen promising results. A final inspection and maintenance cleaning of the basins was performed on March 18 2020. In this 6 month time period some of the retrofitted basins in high pedestrian traffic areas have shown a very good effectiveness of the hooded outlets ability to capture floatables (photo attached). Debris captured included plastic bottles and caps, cigarette buds, styrofoam, and plastic wrappers.

As can be seen in the attached photo the hooded outlets located in high pedestrian traffic areas proved effective in removing floatable debris which would otherwise be discharged into the Quinnipiac River or one of its tributaries.
